INSTALLATION INSTRUCTIONS FOR 5874PBF.

PART NUMBER 0002077650.D REVISION

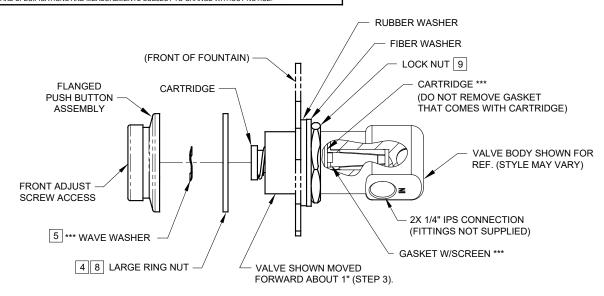
ASSEMBLED 5874PBF (FLUSH MOUNT APPLICATION ONLY)

SEE SHEET 2 OF 2 FOR 5874PB RECESSED MOUNT INSTRUCTIONS.

- 9 PUSH VALVE BACK TOWARD THE INSIDE OF BRACKET AND TIGHTEN LOCKNUT (SEE ILLUSTRATION ABOVE).
- 10) TIGHTEN PUSH BUTTON ASSEMBLY USING UNIVERSAL SPANNER WRENCH PROVIDED.

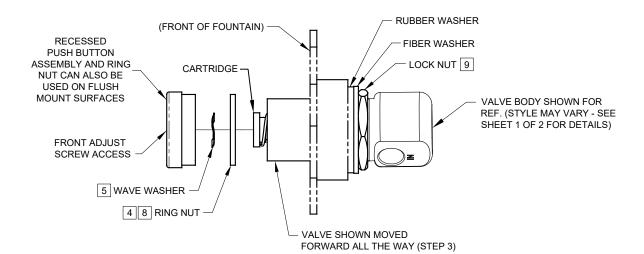
ASSEMBLED 5874PB
(RECESSED MOUNT APPLICATION SHOWN)

SEE SHEET 1 OF 2 FOR FLUSH MOUNT INSTRUCTIONS.
