INSTALLATION INSTRUCTIONS FOR 5874PBF.

5874PB/5874PBF/VRK5874/VRK5874HF

ΙΝΙΏΤΔΙ Ι ΔΤΙΩΝ

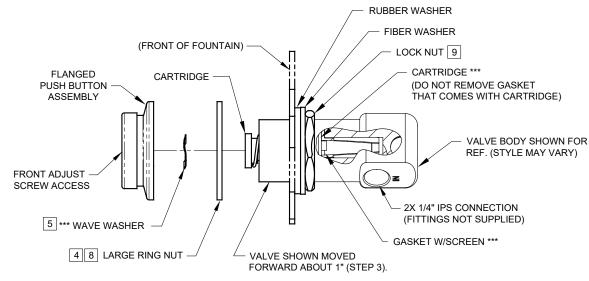
*** MODEL VRK5874 & VRK5874HF- VALVE REPAIR KITS INCLUDE THESE ITEMS

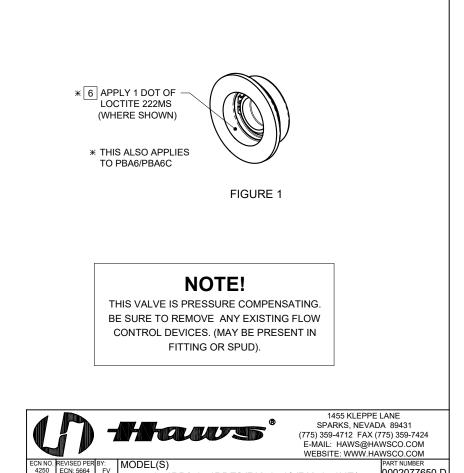
ASSEMBLED 5874PBF

- 9 PUSH VALVE BACK TOWARD THE INSIDE OF BRACKET AND TIGHTEN LOCKNUT (SEE ILLUSTRATION ABOVE).
- 10) TIGHTEN PUSH BUTTON ASSEMBLY USING UNIVERSAL SPANNER WRENCH PROVIDED.

(FLUSH MOUNT APPLICATION ONLY)

- 6 APPLY ONE (1) DOT OF LOCTITE 222MS, ON THE FEMALE THREADS OF BUTTON ASSEMBLY LEAVING THE FIRST AND LAST THREADS FREE. (FIGURE 1). CAUTION: EXCESS LOCTITE CAN CAUSE THREADS TO LOCK VERY TIGHTLY, MAKING REPAIRS DIFFICULT.

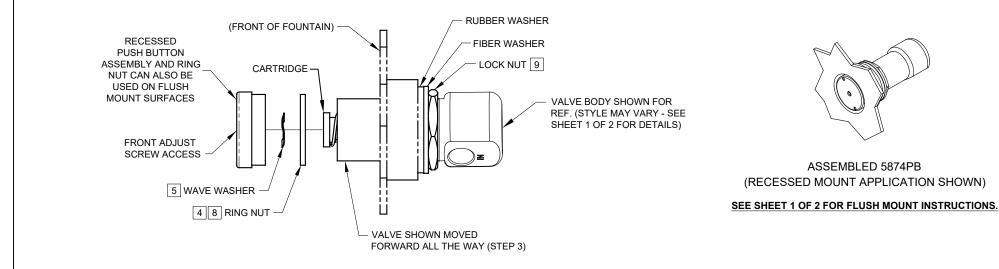
INSTALLATION INSTRUCTIONS FOR 5874PB.

- 5 PLACE WAVE WASHER INSIDE OF PUSH BUTTON ASSEMBLY (MUST BE IN PLACE).
- 6 APPLY ONE (1) DOT OF LOCTITE 222MS, ON THE FEMALE THREADS OF BUTTON ASSEMBLY LEAVING THE FIRST AND LAST THREADS FREE. (FIGURE 1). CAUTION: EXCESS LOCTITE CAN CAUSE THREADS TO LOCK VERY TIGHTLY, MAKING REPAIRS DIFFICULT.
