## INSTALLATION/REPLACEMENT INSTRUCTIONS FOR 5874PBF

<b>Haws</b> ®		1455 KLEPPE LANE SPARKS, NEVADA 89431 (775) 359-4712 FAX (775) 359-7424 E-MAIL: HAWS@HAWSCO.COM WEBSITE: WWW.HAWSCO.COM	
ECN NO. 4250	REVISED PER ECN: 5945	BY: FV	MODEL(S)		PART NUMBER
DRAWN: LM	DATE: 06/08/16	CHKD.: JC	5874PB/5874PBF/VRK5874/VRK5874HF/ PBA6/PBA6C/PBA7/PBA7C		0002077650.D
APPROVED: FV	DATE: 09/27/23	SCALE: NA	DRAWING TYPE:	INSTALLATION	REVISION 11
				SIZE: A	SHEET 1 OF 3

### INSTALLATION/REPLACEMENT INSTRUCTIONS FOR 5874PB

## REPLACEMENT INSTRUCTIONS FOR VRK5874/VRK5874HF

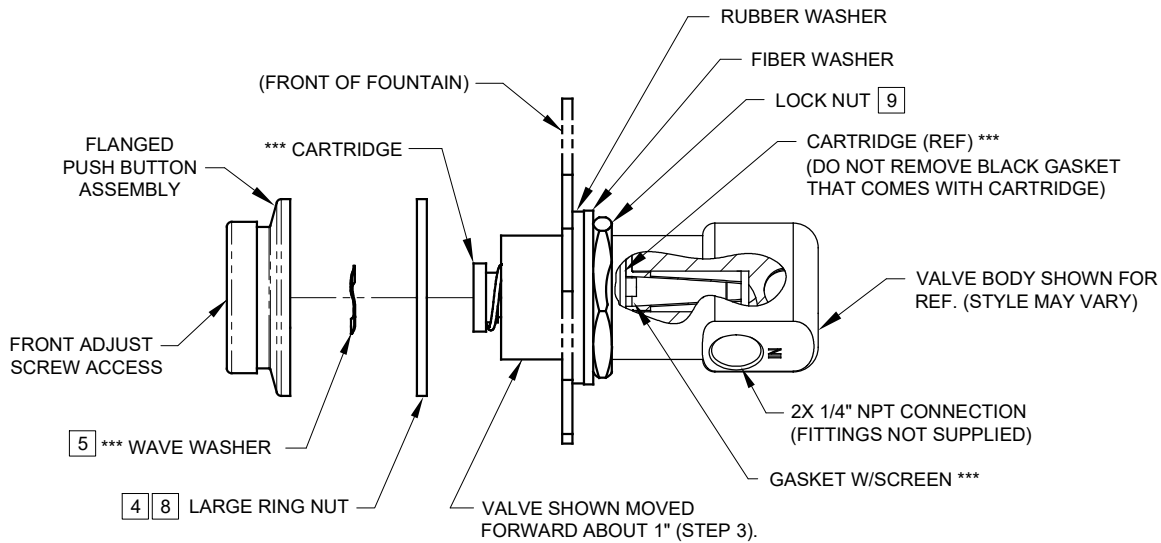
ASSEMBLED 5874PBF  
(FLUSH MOUNT APPLICATION ONLY)

\*\*\* MODEL VRK5874 & VRK5874HF - VALVE REPAIR KITS INCLUDE THESE ITEMS (SEE SHEET 3 OF 3 FOR REPLACEMENT INSTRUCTIONS)

- 1) FOLLOW INSTRUCTIONS CAREFULLY ON O&M MANUAL (PAGE 2 OF 7) WHEN REMOVING OLD VALVE. **NOTE: SEE PARTS BREAKDOWN (PAGE 4 OF 7) FOR ADDITIONAL NOTES.**

- 2) VERIFY THAT LOCK NUT, FIBER, AND RUBBER WASHERS ARE POSITIONED SLIGHTLY PAST MIDWAY OF THREADS ON NEW VALVE BODY.
- 3) INSERT VALVE INTO BRACKET FROM INSIDE AND PUSH FORWARD ABOUT 1".

- 4) THREAD LARGE RING NUT ONTO VALVE BODY, APPROXIMATELY 1" INTO VALVE.
- 5) PLACE WAVE WASHER INSIDE OF FLANGED PUSH BUTTON ASSEMBLY (**MUST ALWAYS BE IN PLACE**).

- 6) APPLY ONE (1) DOT OF LOCTITE 222MS, ON THE FEMALE THREADS OF BUTTON ASSEMBLY LEAVING THE FIRST AND LAST THREADS FREE. (FIGURE 1). **CAUTION: EXCESS LOCTITE CAN CAUSE THREADS TO LOCK VERY TIGHTLY, MAKING REPAIRS DIFFICULT.**

- \*\*7) THREAD FLANGED PUSH BUTTON ASSEMBLY ON VALVE UNTIL WAVE WASHER MAKES SLIGHT CONTACT WITH STEM OF CARTRIDGE. **CAUTION: DO NOT HAND-TIGHTEN.**
- 8) UNTHREAD RING NUT FORWARD UNTIL IT STOPS FLUSH WITH PUSH BUTTON ASSEMBLY.

- 9) PUSH VALVE BACK TOWARD THE INSIDE OF BRACKET AND TIGHTEN LOCKNUT (SEE ILLUSTRATION ABOVE).
- 10) TIGHTEN PUSH BUTTON ASSEMBLY USING UNIVERSAL SPANNER WRENCH PROVIDED WITH MODEL 5874PBF.

\*\* OVERTIGHTENING WILL PRE-ACTUATE VALVE AND CAUSE WEEPAGE, WHILE NOT ENOUGH CONTACT BETWEEN WAVE WASHER AND STEM CAN CAUSE A LOW FLOW CONDITION.

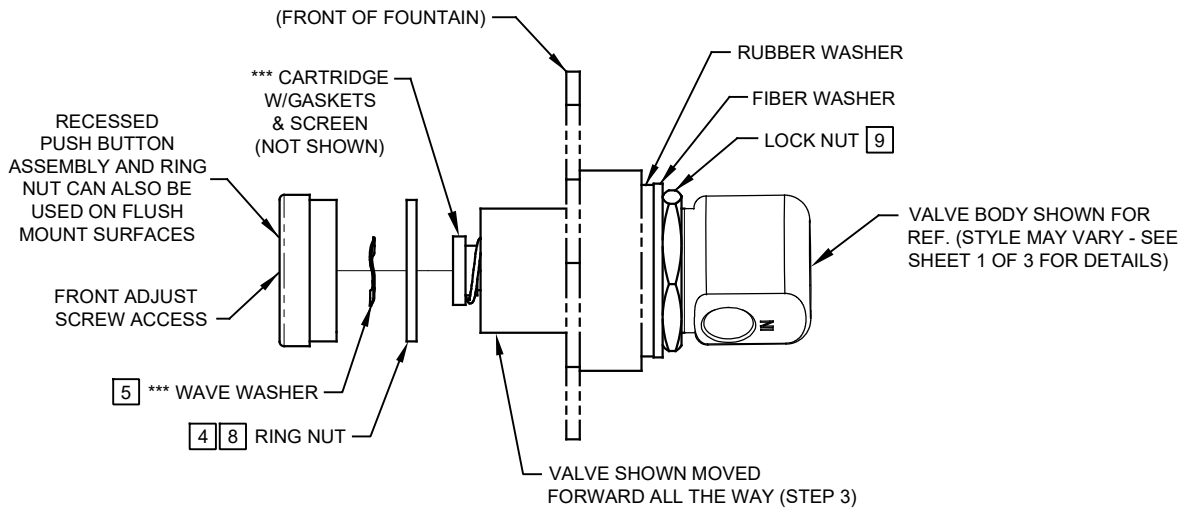
ASSEMBLED 5874PB  
(RECESSED MOUNT APPLICATION SHOWN)  
**SEE SHEET 1 OF 3 FOR FLUSH MOUNT INSTRUCTIONS.**

\*\*\* MODEL VRK5874 & VRK5874HF - VALVE REPAIR KITS INCLUDE THESE ITEMS  
(SEE SHEET 3 OF 3 FOR REPLACEMENT INSTRUCTIONS)

- 2) VERIFY THAT LOCK NUT, FIBER WASHER, AND RUBBER WASHERS ARE POSITIONED TOWARD BOTTOM END OF THREADS ON NEW VALVE BODY.
- 3) INSERT VALVE INTO BRACKET FROM INSIDE, AND PUSH ALL THE WAY FORWARD (SEE ILLUSTRATION ABOVE).

- [4] THREAD RING NUT ONTO VALVE BODY, AS FAR IN AS POSSIBLE, TOWARD FRONT OF FOUNTAIN. **NOTE: IF REPLACING A 5871 OR 5872 SERIES VALVE, YOU MAY HAVE TO CONTACT HAWS TECHNICAL SUPPORT.**

- [5] PLACE WAVE WASHER INSIDE OF PUSH BUTTON ASSEMBLY (**MUST ALWAYS BE IN PLACE**).
- [6] APPLY ONE (1) DOT OF LOCTITE 222MS, ON THE FEMALE THREADS OF BUTTON ASSEMBLY LEAVING THE FIRST AND LAST THREADS FREE. (FIGURE 1). **CAUTION: EXCESS LOCTITE CAN CAUSE THREADS TO LOCK VERY TIGHTLY, MAKING REPAIRS DIFFICULT.**

- \*\*7) THREAD PUSH BUTTON ASSEMBLY ON VALVE UNTIL WAVE WASHER MAKES SLIGHT CONTACT WITH STEM OF CARTRIDGE. **CAUTION: DO NOT HAND-TIGHTEN.**
- [8] UNTHREAD RING NUT FORWARD UNTIL IT STOPS FLUSH WITH PUSH BUTTON ASSEMBLY.

- [9] PUSH VALVE BACK TOWARD THE INSIDE OF BRACKET AND TIGHTEN LOCKNUT (SEE ILLUSTRATION ABOVE).
- 10) TIGHTEN PUSH BUTTON ASSEMBLY USING UNIVERSAL SPANNER WRENCH PROVIDED WITH MODEL 5874PB.
