1 MODEL VPK5874 - VALVE REPAIR KIT (INCLUDES THESE ITEMS)
ALSO USED ON 5874 & 5874PB

INSTALLATION INSTRUCTIONS FOR 5874PBF

INSTALLATION INSTRUCTIONS FOR 5874PB

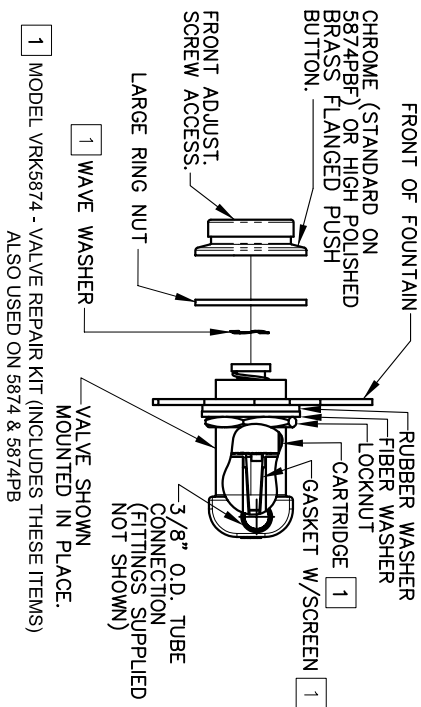
FIGURE 1 ASSEMBLED 5874PBF

- 1.) INSERT VALVE INTO FOUNTAIN FROM INSIDE.
- 2.) THREAD LARGE RING NUT ONTO VALVE BODY, APPROX. 1" INTO VALVE.
- 3.) PLACE WAVE WASHER INSIDE OF FLANGED PUSH-BUTTON ASSY.
- 4.) APPLY ONE (1) DOT OF LOCTITE 222MS, ON THE FEMALE THREADS OF BUTTON ASSEMBLY, LEAVING THE FIRST AND LAST THREADS FREE. (FIGURE1). CAUTION: EXCESS LOCTITE CAN CAUSE THREADS TO LOCK VERY TIGHTLY, MAKING REPAIRS DIFFICULT.
- 5.) THREAD FLANGED PUSH-BUTTON ASSY. ON VALVE UNTIL WAVE WASHER MAKES CONTACT WITH STEM OF CARTRIDGE. CAUTION: DO NOT HAND TIGHTEN.
- 6.) UNTHREAD LARGE RING NUT FORWARD, UNTIL IT STOPS FLUSH WITH FLANGED PUSH-BUTTON ASSY.
- 7.) PUSH VALVE BACK TOWARD THE INSIDE OF FOUNTAIN AND TIGHTEN LOCK NUT. (SEE ILLUSTRATION ABOVE.)
- 8.) TIGHTEN FLANGED PUSH-BUTTON ASSY. USING UNIVERSAL SPANNER WRENCH PROVIDED.

*APPLY 1 DOT OF LOCTITE 222MS

*THIS ALSO APPLIES TO PBA6 AND PBA6HPB

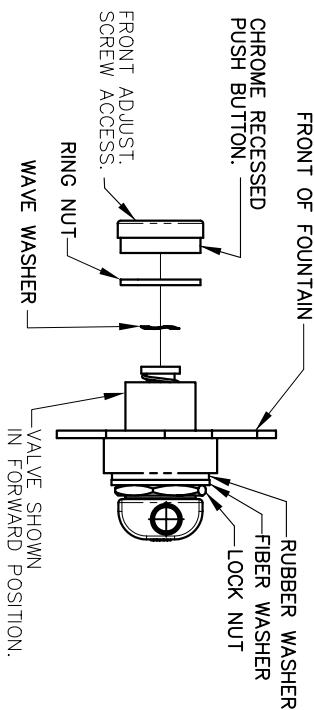
FIGURE 2 ASSEMBLED 5874PB

- 1.) VERIFY THAT LOCK NUT, FIBER AND RUBBER WASHERS ARE AT BOTTOM OF VALVE.
- 2.) INSERT VALVE INTO FOUNTAIN FROM INSIDE, AND PUSH FORWARD (SEE ILLUSTRATION ABOVE).

- 3.) THREAD RING NUT ONTO VALVE BODY, AS FAR AS POSSIBLE TOWARDS FRONT OF FOUNTAIN.
- 4.) PLACE WAVE WASHER INSIDE OF FLANGED PUSH-BUTTON ASSY.
- 5.) APPLY ONE (1) DOT OF LOCTITE 222MS, ON THE FEMALE THREADS OF BUTTON ASSEMBLY, LEAVING THE FIRST AND LAST THREADS FREE. (FIGURE 2). CAUTION: EXCESS LOCTITE CAN CAUSE THREADS TO LOCK VERY TIGHTLY, MAKING REPAIRS DIFFICULT.

- 6.) THREAD PUSH-BUTTON ASSY. ON VALVE UNTIL WAVE WASHER MAKES CONTACT WITH STEM OF CARTRIDGE. CAUTION: DO NOT HAND TIGHTEN.
- 7.) UNTHREAD RING NUT FORWARD, UNTIL IT STOPS FLUSH WITH PUSH-BUTTON ASSY.

- 8.) PUSH VALVE BACK TOWARD THE INSIDE OF FOUNTAIN AND TIGHTEN LOCK NUT. (SEE ILLUSTRATION ABOVE.)
- 9.) TIGHTEN PUSH-BUTTON ASSY. USING UNIVERSAL SPANNER WRENCH PROVIDED.

*APPLY 1 DOT OF LOCTITE 222MS
