# INSTALLATION, OPERATION & MAINTENANCE INSTRUCTIONS

No. 2076415 (14)

## Model 1025/1025G Drinking Fountain

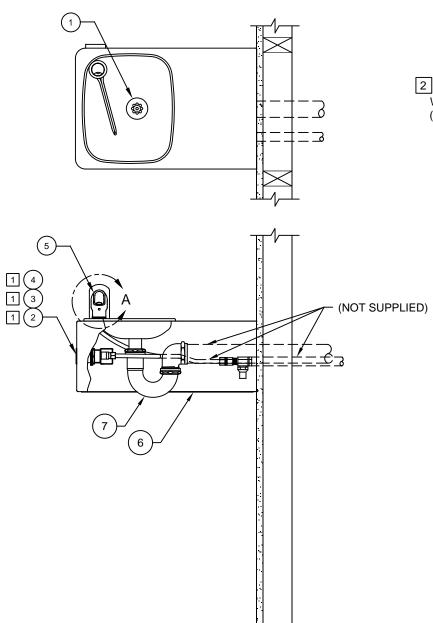
## **PARTS BREAKDOWN**

1 5874PB (ITEM 2) INCLUDES VRK5874 CARTRIDGE ASSEMBLY (ITEM 3) AND PBA7 RECESSED PUSH BUTTON (ITEM 4).

2 ENSURE TUBE IS DISCONNECTED FROM PUSH BUTTON VALVE BODY PRIOR TO REMOVAL. APPLY ONE DROP OF LOCTITE 222MS TO NOZZLE THREADS PRIOR TO FASTENING BACK ONTO BUBBLER HEAD. RE-ATTACH TUBE TO VALVE.

ITEM	DESCRIPTION	1025/1025
1	STRAINER, WASTE ASSEMBLY	6466
2	BUTTON, PUSH, RECESSED, PCP W/ VALVE	5874PB
3	VALVE REPAIR KIT	VRK5874
4	BUTTON ASSEMBLY, PUSH, 5874	PBA7
5	BUBBLER HEAD ASSEMBLY, PCP	5703M
6	PLATE, BOTTOM	PBM1025
7	TRAP	0005987000

**DETAIL A ROTATED 90° INTO VIEW**
