## FEATURES & BENEFITS

Model 5874PB push-button activated fountain valve is the only all stainless steel valve body that is machined out of solid bar stock, is fully serviceable through the front of the push button assembly offering access to the water control cartridge and integral water supply strainer, and with front access to the water stream height adjustment for easy maintenance without having to remove the valve. Operating pressure range of 30 to 90 psi (2.1 to 6.2 bar).

## INSTALLATION/REPLACEMENT INSTRUCTIONS FOR 5874PBF

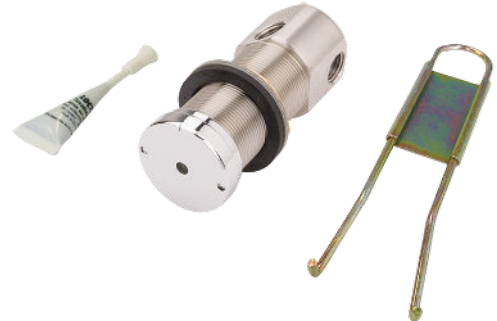
The push-button activated valve offers the only all stainless steel valve body that is machined out of solid bar stock, is fully serviceable through the front of the push button assembly offering access to the water control cartridge and integral water supply strainer, and with front access to the water stream height adjustment for easy maintenance without having to remove the valve. Operating pressure range of 30 to 90 psi (2.1 to 6.2 bar).

All chrome plated brass push button resists vandalism by allowing it to spin without unscrewing.

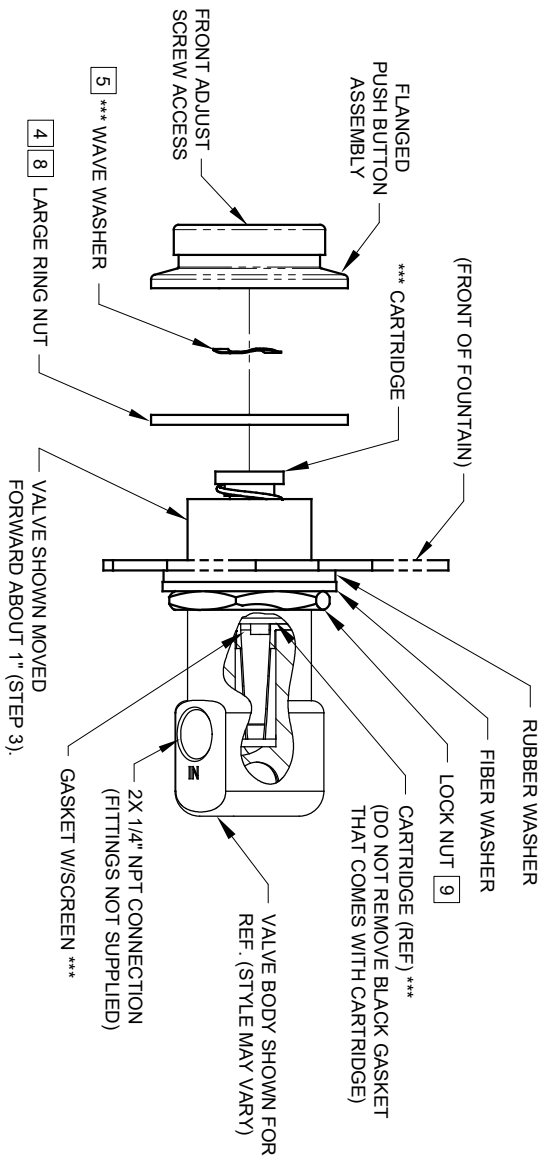
\*\*\* MODEL VRK5874 & VRK5874HF- VALVE REPAIR KITS INCLUDE THESE ITEMS  
(SEE SHEET 3 OF 3 FOR REPLACEMENT INSTRUCTIONS)

9) PUSH VALVE BACK TOWARD THE INSIDE OF BRACKET AND TIGHTEN LOCKNUT (SEE ILLUSTRATION ABOVE).

ASSEMBLED 5874PBF  
(FLUSH MOUNT APPLICATION ONLY)

1) FOLLOW INSTRUCTIONS CAREFULLY ON O&M MANUAL (PAGE 2 OF 7) WHEN REMOVING OLD VALVE. **NOTE: SEE PARTS BREAKDOWN (PAGE 4 OF 7) FOR ADDITIONAL NOTES.**

2) VERIFY THAT LOCK NUT, FIBER, AND RUBBER WASHERS ARE POSITIONED SLIGHTLY PAST MIDWAY OF THREADS ON NEW VALVE BODY.

3) INSERT VALVE INTO BRACKET FROM INSIDE AND PUSH FORWARD ABOUT 1".

4) THREAD LARGE RING NUT ONTO VALVE BODY, APPROXIMATELY 1" INTO VALVE.

5) PLACE WAVE WASHER INSIDE OF FLANGED PUSH BUTTON ASSEMBLY (**MUST ALWAYS BE IN PLACE**).

6) APPLY ONE (1) DOT OF LOCTITE 222MS, ON THE FEMALE THREADS OF BUTTON ASSEMBLY LEAVING THE FIRST AND LAST THREADS FREE. (FIGURE 1). **CAUTION: EXCESS LOCTITE CAN CAUSE THREADS TO LOCK VERY TIGHTLY, MAKING REPAIRS DIFFICULT.**

\*\*7) THREAD FLANGED PUSH BUTTON ASSEMBLY ON VALVE UNTIL WAVE WASHER MAKES SLIGHT CONTACT WITH STEM OF CARTRIDGE. **CAUTION: DO NOT HAND-TIGHTEN.**

8) UNTHREAD RING NUT FORWARD UNTIL IT STOPS FLUSH WITH PUSH BUTTON ASSEMBLY.

10) TIGHTEN PUSH BUTTON ASSEMBLY USING UNIVERSAL SPANNER WRENCH PROVIDED WITH MODEL 5874PBF.

\*\* OVERTIGHTENING WILL PRE-ACTUATE VALVE AND CAUSE WEEPAGE, WHILE NOT ENOUGH CONTACT BETWEEN WAVE WASHER AND STEM CAN CAUSE A LOW FLOW CONDITION.

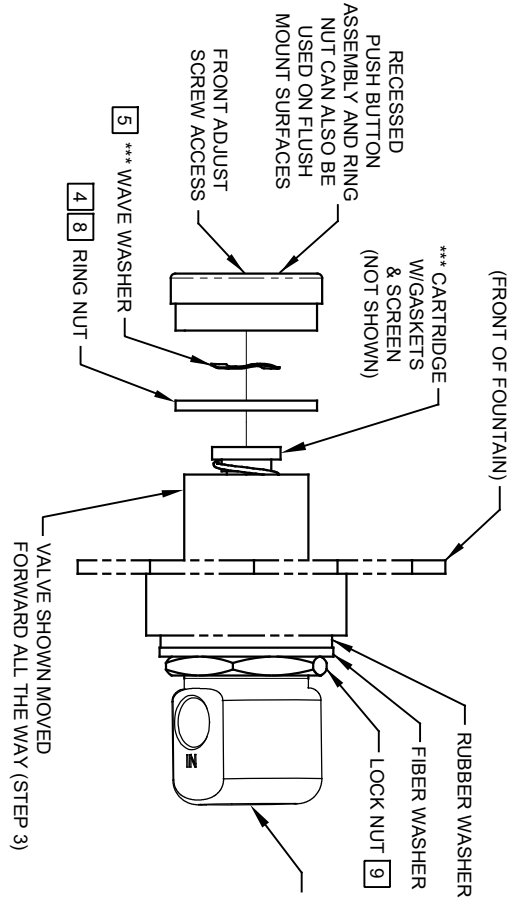
\*\*\* MODEL VRK5874 & VRK5874HF - VALVE REPAIR KITS INCLUDE THESE ITEMS  
(SEE SHEET 3 OF 3 FOR REPLACEMENT INSTRUCTIONS)

ASSEMBLED 5874PB  
(RECESSED MOUNT APPLICATION SHOWN)  
SEE SHEET 1 OF 3 FOR FLUSH MOUNT INSTRUCTIONS.

\* [6] APPLY 1 DOT OF  
LOCTITE 222MS  
(WHERE SHOWN)

INSTALLATION/REPLACEMENT INSTRUCTIONS FOR 5874PB

- 1) FOLLOW INSTRUCTIONS CAREFULLY ON O&M MANUAL (PAGE 2 OF 7) WHEN REMOVING OLD VALVE. **NOTE: SEE PARTS BREAKDOWN (PAGE 4 OF 7) FOR ADDITIONAL NOTES.**
- 2) VERIFY THAT LOCK NUT, FIBER WASHER, AND RUBBER WASHERS ARE POSITIONED TOWARD BOTTOM END OF THREADS ON NEW VALVE BODY.
- 3) INSERT VALVE INTO BRACKET FROM INSIDE, AND PUSH ALL THE WAY FORWARD (SEE ILLUSTRATION ABOVE).

- 4) THREAD RING NUT ONTO VALVE BODY, AS FAR IN AS POSSIBLE, TOWARD FRONT OF FOUNTAIN. **NOTE: IF REPLACING A 5871 OR 5872 SERIES VALVE, YOU MAY HAVE TO CONTACT HAWS TECHNICAL SUPPORT.**
- 5) PLACE WAVE WASHER INSIDE OF PUSH BUTTON ASSEMBLY (MUST ALWAYS BE IN PLACE).

- 6) APPLY ONE (1) DOT OF LOCTITE 222MS, ON THE FEMALE THREADS OF BUTTON ASSEMBLY LEAVING THE FIRST AND LAST THREADS FREE. (FIGURE 1). **CAUTION: EXCESS LOCTITE CAN CAUSE THREADS TO LOCK VERY TIGHTLY, MAKING REPAIRS DIFFICULT.**

- \*\*7) THREAD PUSH BUTTON ASSEMBLY ON VALVE UNTIL WAVE WASHER MAKES SLIGHT CONTACT WITH STEM OF CARTRIDGE. **CAUTION: DO NOT HAND-TIGHTEN.**

- 8) UNTHREAD RING NUT FORWARD UNTIL IT STOPS FLUSH WITH PUSH BUTTON ASSEMBLY.

- 9) PUSH VALVE BACK TOWARD THE INSIDE OF BRACKET AND TIGHTEN LOCKNUT (SEE ILLUSTRATION ABOVE).

- 10) TIGHTEN PUSH BUTTON ASSEMBLY USING UNIVERSAL SPANNER WRENCH PROVIDED WITH MODEL 5874PB.

\*\* OVERTIGHTENING WILL PRE-ACTUATE VALVE AND CAUSE WEEPAGE. WHILE NOT ENOUGH CONTACT BETWEEN WAVE WASHER AND STEM CAN CAUSE A LOW FLOW CONDITION.

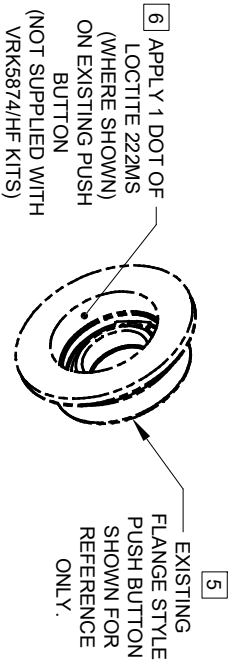
FIGURE 1

- 6) APPLY ONE (1) DOT OF LOCOTITE 222MS. ON THE FEMALE THREADS OF EXISTING BUTTON ASSEMBLY LEAVING THE FIRST AND LAST THREADS FREE. (SEE FIGURE 1). **CAUTION: EXCESS LOCOTITE CAN CAUSE THREADS TO LOCK VERY TIGHTLY, MAKING REPAIRS DIFFICULT.**

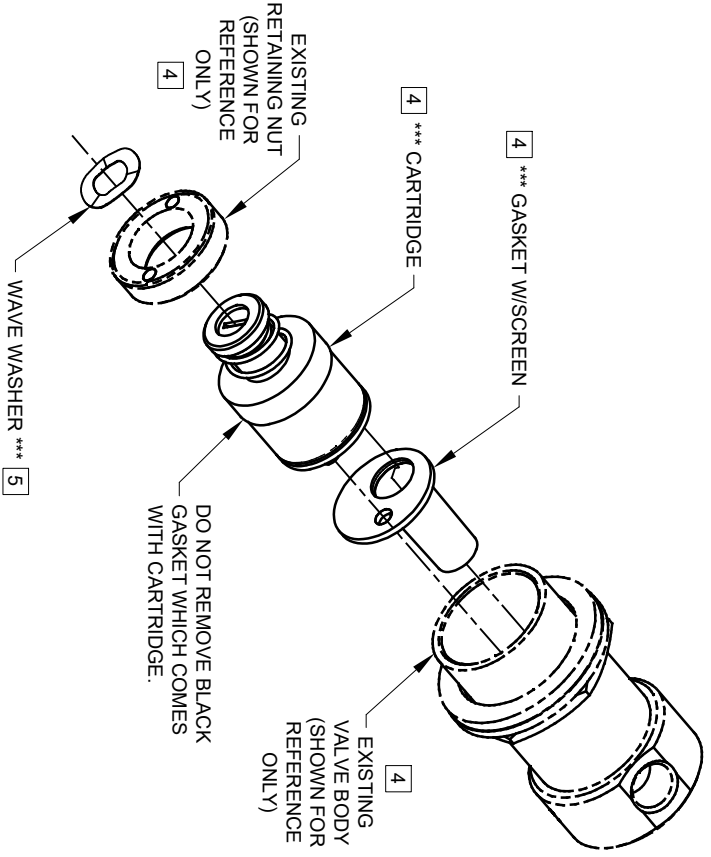
## REPLACEMENT INSTRUCTIONS FOR VRK5874/VRK5874HF

- 3) PULL EXISTING CARTRIDGE ASSEMBLY WITH GASKET SCREEN OUT.
- 4) WHEN INSERTING NEW CARTRIDGE ASSEMBLY WITH GASKET SCREEN, FOLLOW THESE IMPORTANT STEPS:

- MAKE SURE THERE IS NO DEBRIS IN THE VALVE BODY BEFORE INSERTING THE CARTRIDGE ASSEMBLY INTO THE VALVE BODY.
  - ALIGN STRAINER WITH LARGE HOLE IN THE VALVE BODY AND ENSURE THE OUTLET PORT ON CARTRIDGE IS ALSO PROPERLY ALIGNED WITH SMALLER OPENING IN VALVE BODY BY TURNING SLIGHTLY INTO PLACE.

- CONFIRM CARTRIDGE HAS BOTTOMED OUT PROPERLY BEFORE INSTALLING RETAINING NUT.
  - THREAD RETAINING NUT UNTIL IT CONTACTS THE CARTRIDGE, THEN TIGHTEN 1-1/4 TURN FARTHER, CHECK FOR LEAKS.

- 1) FOLLOW INSTRUCTIONS CAREFULLY ON O&M MANUAL (PAGE 2 OF 7) WHEN REMOVING VALVE. **NOTE: SEE PARTS BREAKDOWN (PAGE 4 OF 7) FOR ADDITIONAL NOTES.**
- 2) REMOVE FRONT PUSH BUTTON (WITH WAVE WASHER INSIDE) AND RETAINING NUT WITH THE UNIVERSAL SPANNER WRENCH (PN 0006983506 - NOT SUPPLIED WITH VRK5874 AND VRK5874HF KITS).

- (CAUTION: WHEN REPLACING CARTRIDGE W/GASKET ASSEMBLY, DAMAGE CAN OCCUR IF NOT PROPERLY RE-INSTALLED).
- 5) PLACE WAVE WASHER (EXISTING OR NEW) INSIDE OF PUSH BUTTON ASSEMBLY (MUST ALWAYS BE IN PLACE).

- \*\* 7) THREAD EXISTING PUSH BUTTON ASSEMBLY ON VALVE UNTIL WAVE WASHER MAKES SLIGHT SLIGHT CONTACT WITH STEM OF CARTRIDGE. **CAUTION: DO NOT HAND-TIGHTEN.**

- 8) TIGHTEN EXISTING PUSH BUTTON ASSEMBLY USING UNIVERSAL SPANNER WRENCH (PN 0006983506 NOT SUPPLIED WITH VRK5874 AND VRK5874HF KITS).

\*\* OVERTIGHTENING WILL PRE-ACTUATE VALVE AND CAUSE WEEPAGE, WHILE NOT ENOUGH CONTACT BETWEEN WAVE WASHER AND STEM CAN CAUSE A LOW FLOW CONDITION.
