PARTS BREAKDOWN

1455 KLEPPE LANE SPARKS, NEVADA 89431 (775) 359-4712 FAX (775) 359-7424 E-MAIL: HAWS@HAWS.CO.COM WEBSITE: WWW.HAWS.CO.COM	
		ECN NO. REVISED PER BY ECN: 6148 JG	MODEL(S) 1107
DRAWN C.FENNER	DATE 10/25/06	CHKD JG	REVISION 18
APPROVED FV	DATE 02/11/25	SCALE: 1:2	DRAWING TYPE: PARTS BREAKDOWN SIZE: A SHEET 1 OF 1

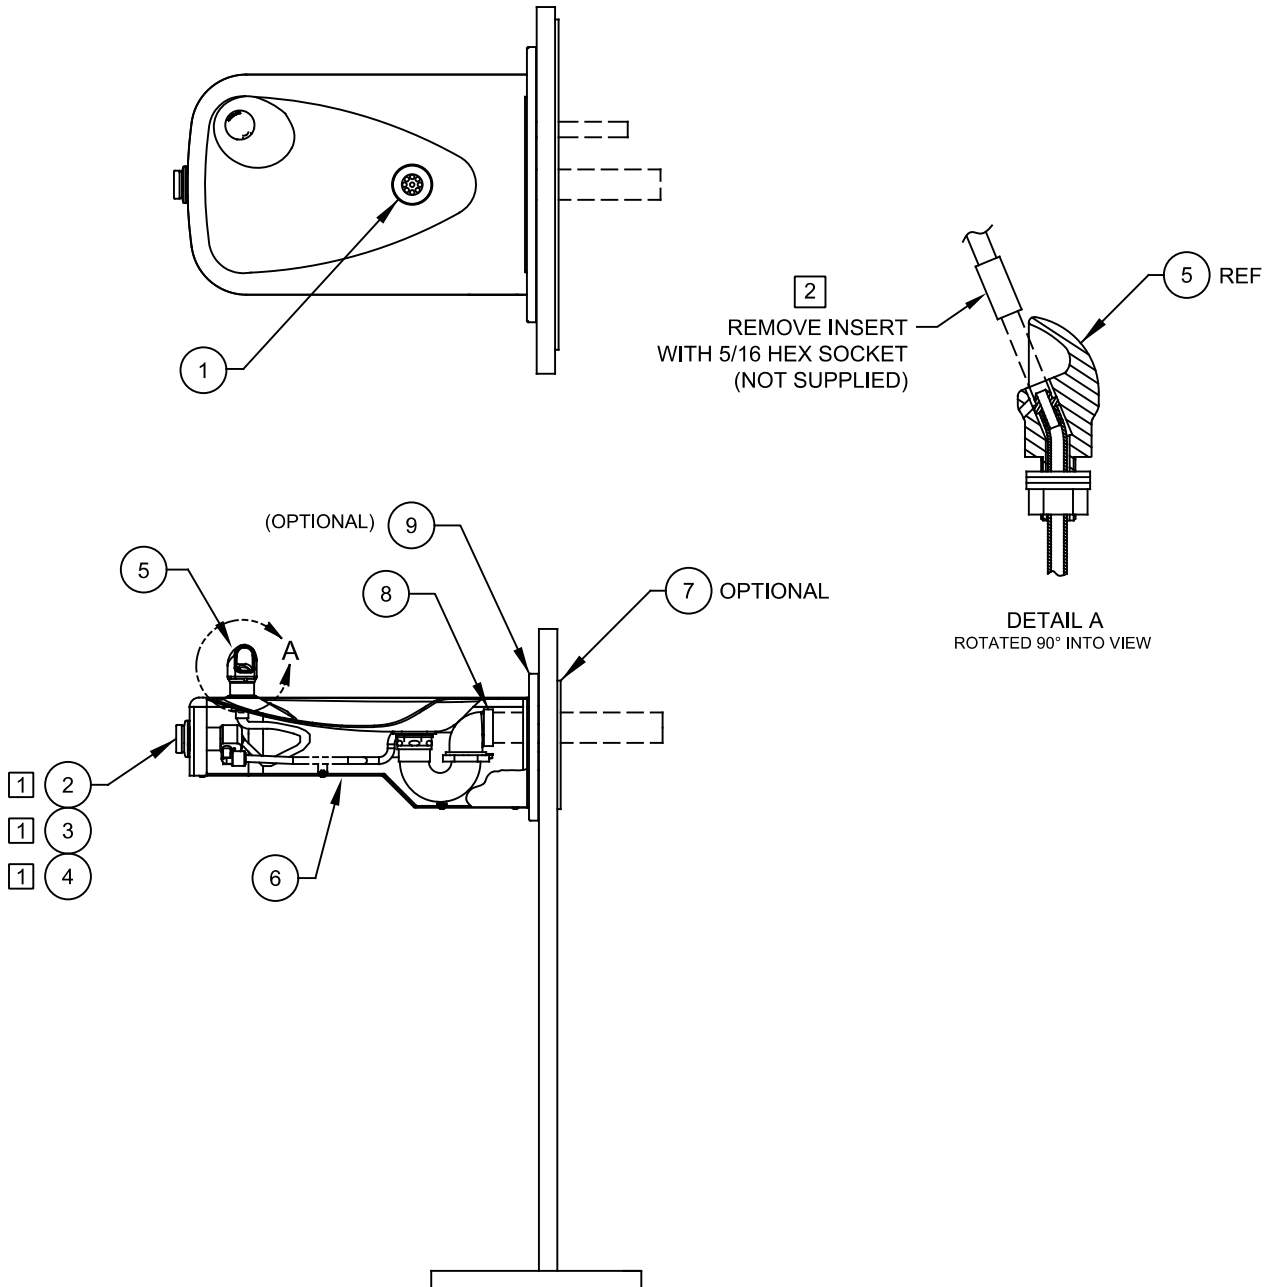
- 1 5874PBF (ITEM 2) INCLUDES VRK5874 CARTRIDGE ASSEMBLY (ITEM 3) AND PBA6 FLANGED PUSH BUTTON (ITEM 4).
- 2 ENSURE TUBE IS DISCONNECTED FROM PUSH BUTTON VALVE BODY PRIOR TO REMOVAL. APPLY ONE DROP OF LOCTITE 222MS TO NOZZLE THREADS PRIOR TO FASTENING BACK ONTO BUBBLER HEAD. RE-ATTACH TUBE TO VALVE.

ITEM	DESCRIPTION	PART NO.
1	STRAINER, WASTE ASSY	6462
2	BUTTON, PUSH, FLANGED, PCP W/ VALVE	5874PBF
3	VALVE REPAIR KIT	VRK5874
4	PUSH BUTTON ASSY	PBA6
5	BUBBLER HEAD ASSY, PCP	5703M
6	PLATE, BOTTOM	PBM1107
* 7	PLATE, MOUNTING	6700
8	TRAP	0005982900
* 9	PANEL, BACK	BP7
