PARTS BREAKDOWN

3150

PART NUMBER 0002077070 REVISION

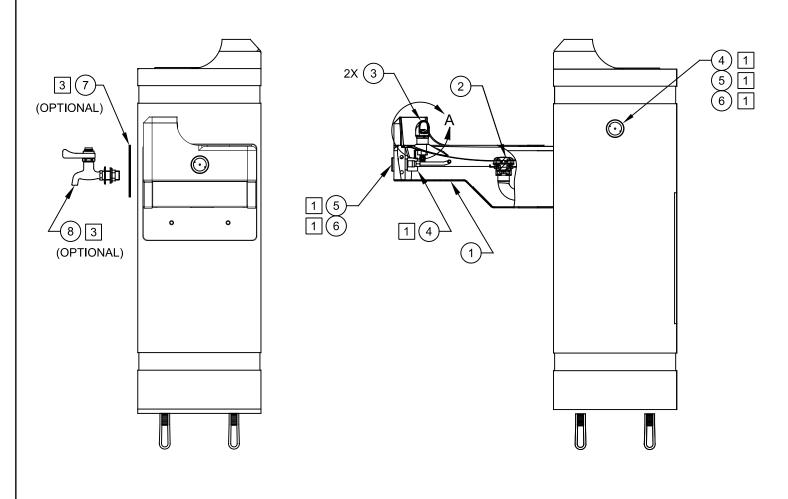
- 1 5874PB (ITEM 4) INCLUDES VRK5874 CARTRIDGE ASSEMBLY (ITEM 5) AND PBA7 RECESSED PUSH BUTTON (ITEM 6).
- 2 ENSURE TUBE IS DISCONNECTED FROM PUSH BUTTON VALVE BODY PRIOR TO REMOVAL. APPLY ONE DROP OF LOCTITE 222MS TO NOZZLE THREADS PRIOR TO FASTENING BACK ONTO BUBBLER HEAD. RE-ATTACH TUBE TO VALVE.
- 3 USE MODEL 6250LF WITH ACCESS PLATE, PN 0004499489.

ITEM	DESCRIPTION	PART NO.
	1	BOTTOM PLATE	PBM1047
	2	STRAINER ASSY	6466
	3	BUBBLER HEAD	5703M
	4	BUTTON, PUSH, RECESSED, W/ VALVE	5874PB
	5	VALVE REPAIR KIT	VRK5874
	6	BUTTON, PUSH, ASSY, F/ 5874	PBA7
*	7	ACCESS PLATE, W/ HOLE	0004499489
*	8	BIB FAUCET, SELF CLOSING	6250LF

DETAIL AROTATED 90° INTO VIEW
