PARTS BREAKDOWN

93300G PART NUMBER 0002077341
REVISION 21

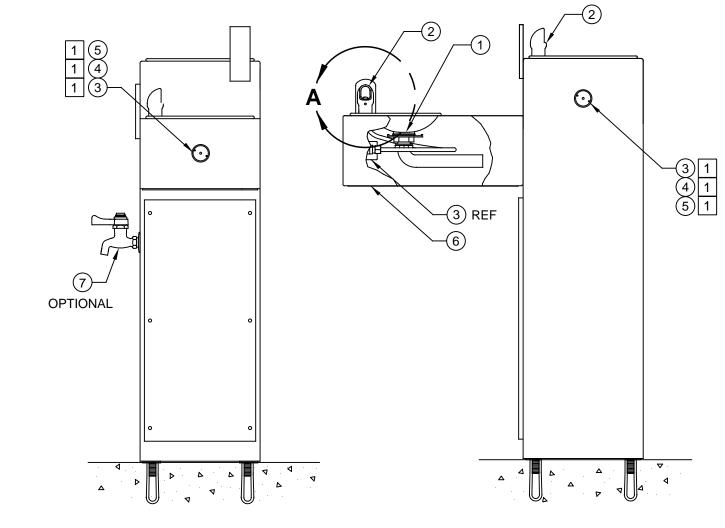
1 5874PB (ITEM 3) INCLUDES VRK5874 CARTRIDGE ASSEMBLY (ITEM 4) AND PBA7 RECESSED PUSH BUTTON (ITEM 5).

2 ENSURE TUBE IS DISCONNECTED FROM PUSH BUTTON VALVE BODY PRIOR TO REMOVAL. APPLY ONE DROP OF LOCTITE 222MS TO NOZZLE THREADS PRIOR TO FASTENING BACK ONTO BUBBLER HEAD. RE-ATTACH TUBE TO VALVE.

ITEM	DESCRIPTION	PART NO.
1	STRAINER ASSY	6466
2	BUBBLER HEAD	5703M
3	BUTTON, PUSH, REC W/ VALVE	5874PB
4	VALVE REPAIR KIT	VRK5874
5	BUTTON, ASSY, PUSH, 5874	PBA7
6	PLATE, BOTTOM	PBM1025
7	BIB FAUCET (OPTIONAL)	6250LF

DETAIL AROTATED 90° INTO VIEW
