PARTS BREAKDOWN

WHEN ORDERING PARTS PLEASE SPECIFY MODEL NUMBER.

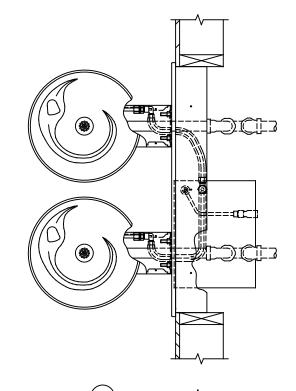
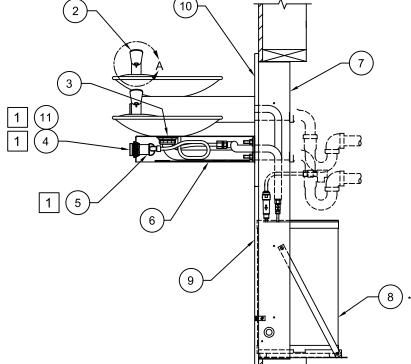
1 5874PBF (ITEM 5) INCLUDES VRK5874 CARTRIDGE ASSEMBLY (ITEM 11) AND PBA6 FLANGED PUSH BUTTON (ITEM 4).

(TUBING CONNECTS TO INSERT ASSY)

DETAIL A ROTATED 90° INTO VIEW
